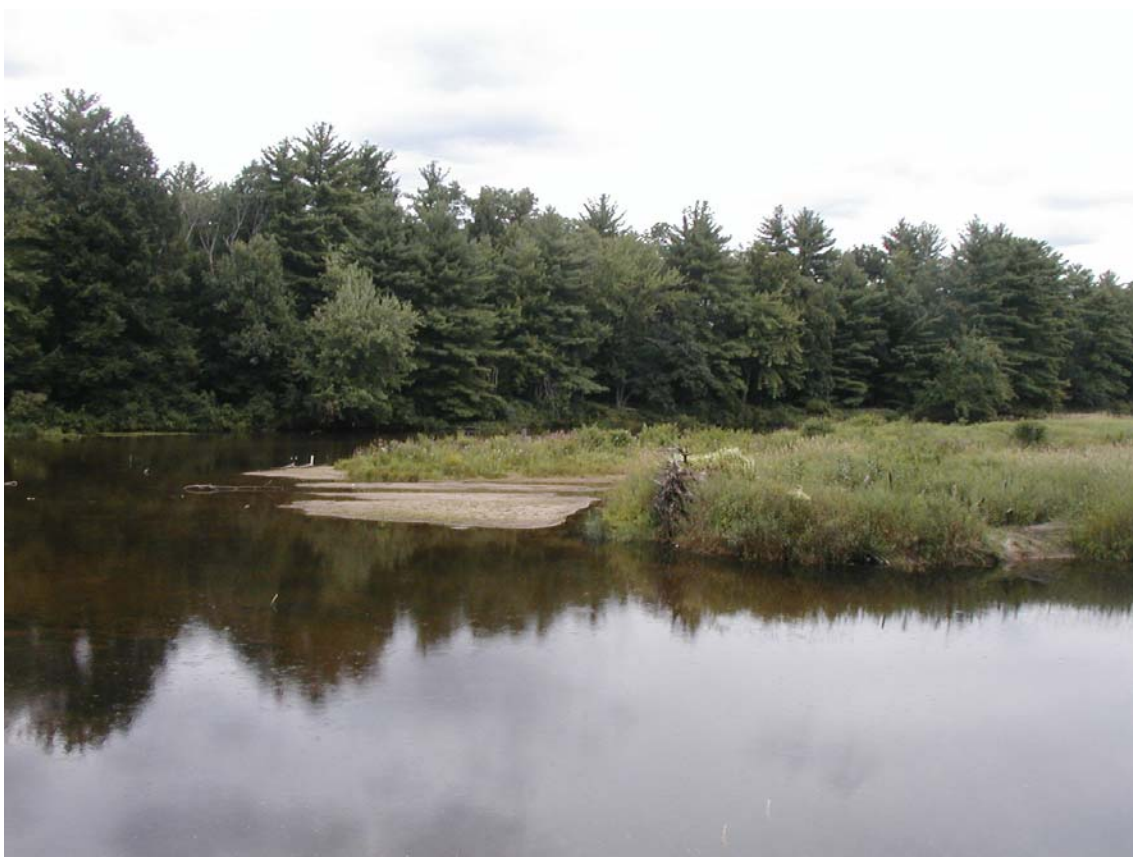
Photo No. 25, Date: 8/6/04, Courtesy Smart Associates
Description: Sand exposed at the upstream edge of this island.

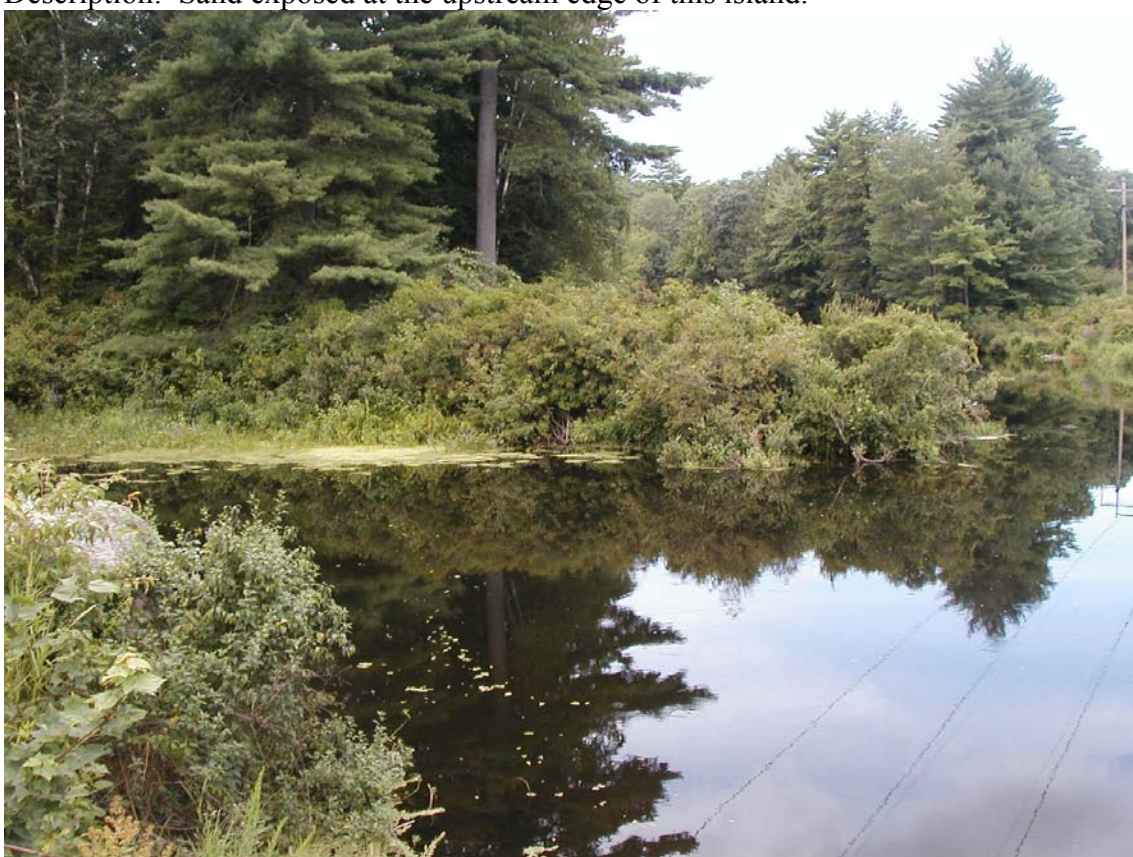
Photo No. 26, Date: 8/6/04, Courtesy Smart Associates
Description: Exit point of the secondary channel remnant, approximately $\frac{1}{4}$ mile upstream of the MVD.

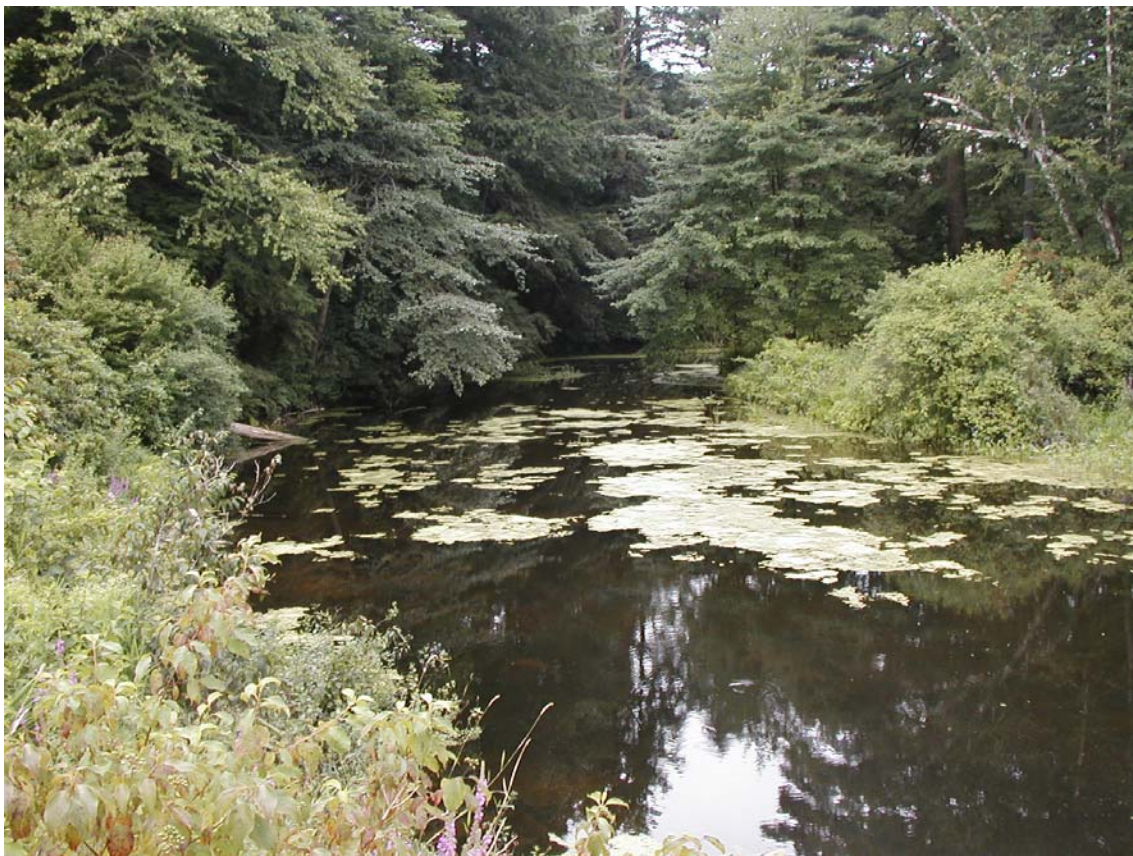
Photo No. 27, Date: 8/6/04, Courtesy Smart Associates
Description: Secondary channel remnant facing upstream.

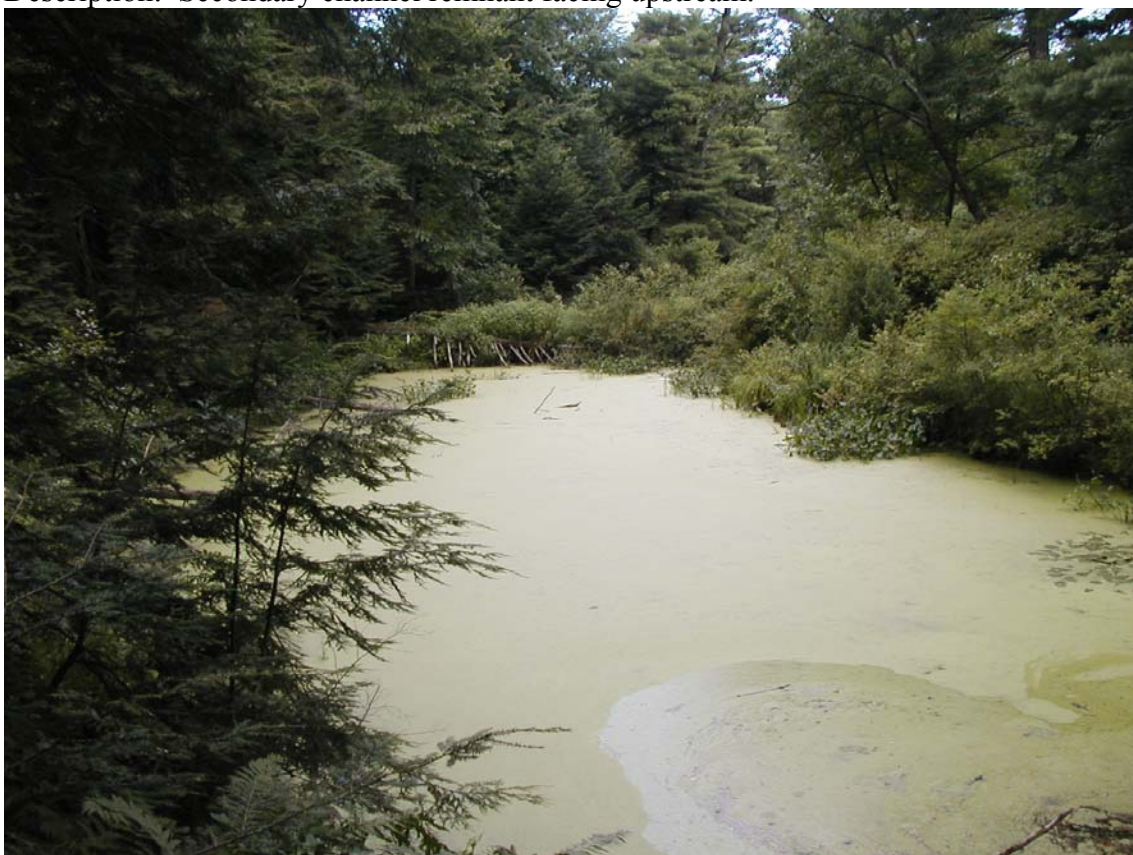
Photo No. 28, Date: 8/6/04, Courtesy Smart Associates
Description: Dominant presence of algae indicates little or no flow through the channel remnant.

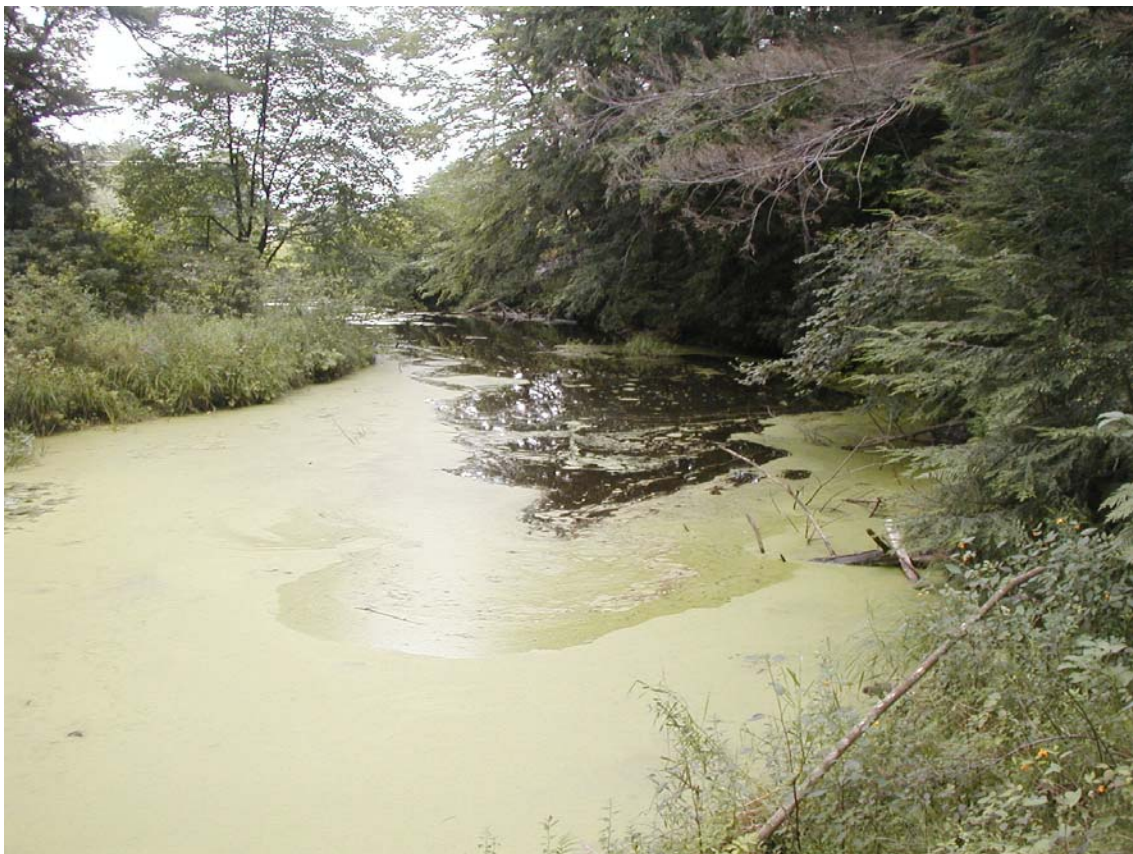
Photo No. 29, Date: 8/6/04, Courtesy Smart Associates

Description: View of channel facing downstream to the river confluence.

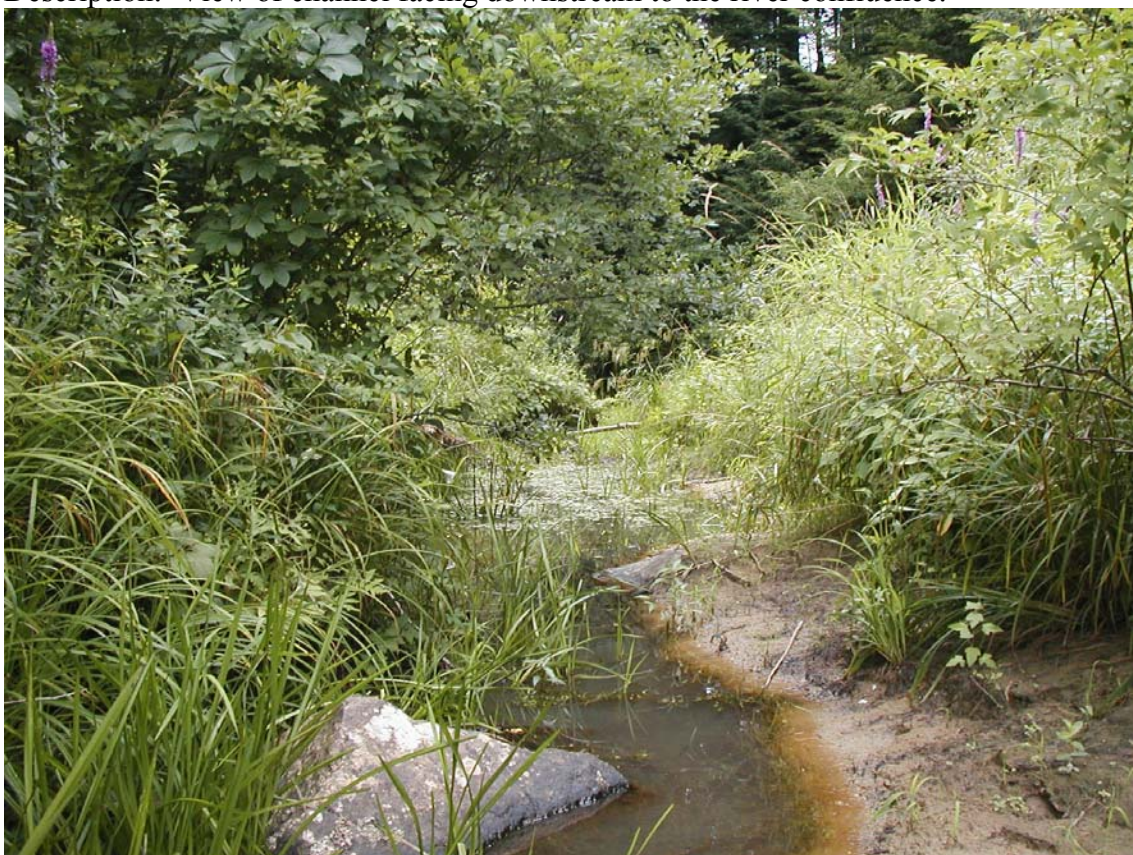
Photo No. 30, Date: 8/6/04, Courtesy Smart Associates

Description: The inlet of the channel remnant is narrow and nearly overgrown with vegetation.

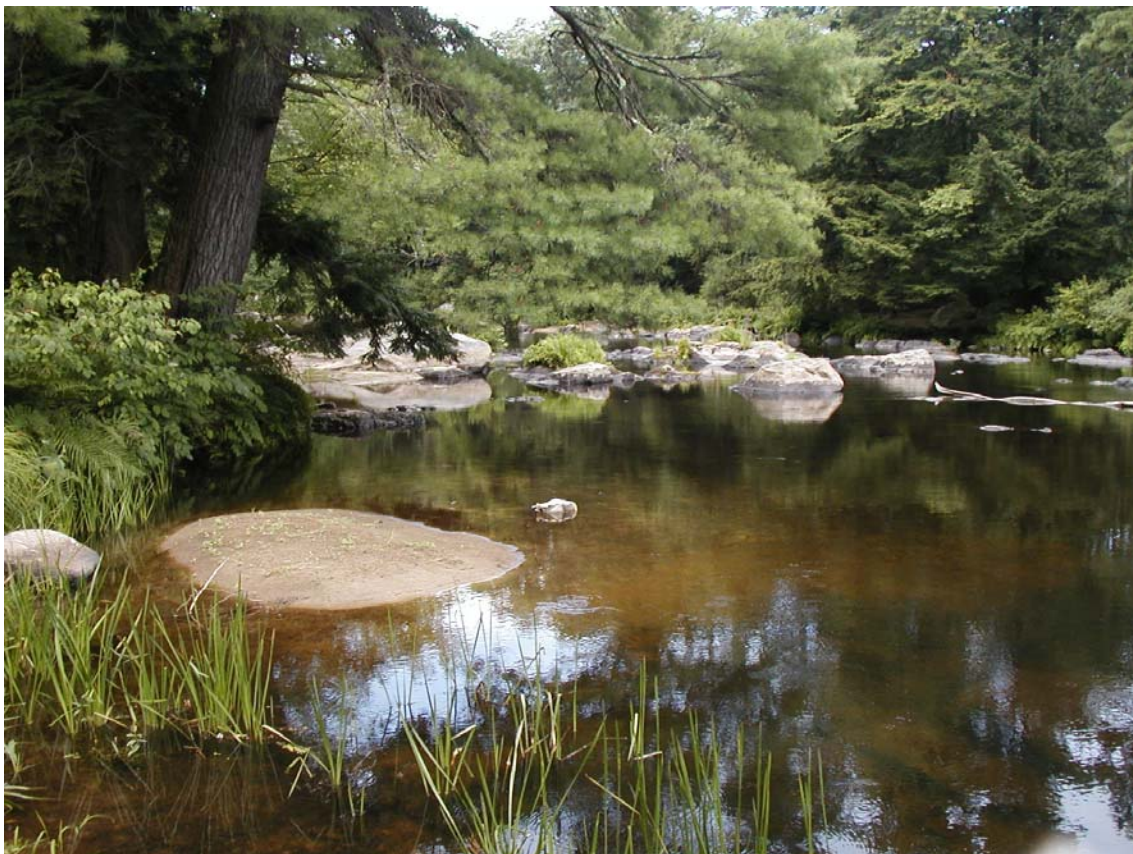
Photo No. 31, Date: 8/6/04, Courtesy Smart Associates

Description: View of the river from the channel remnant entrance, facing upstream.

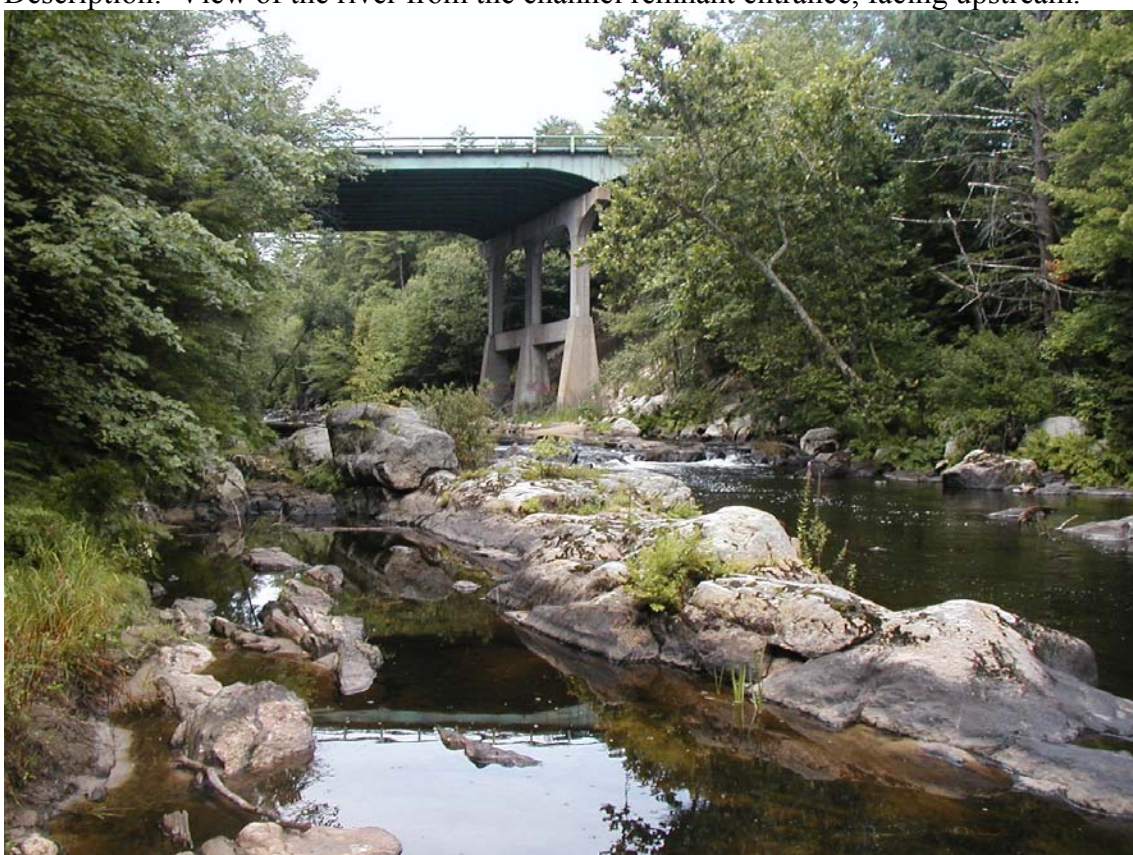
Photo No. 32, Date: 8/6/04, Courtesy Smart Associates

Description: Rocky outcrops appear just downstream of the F.E. Everett bridge crossing.

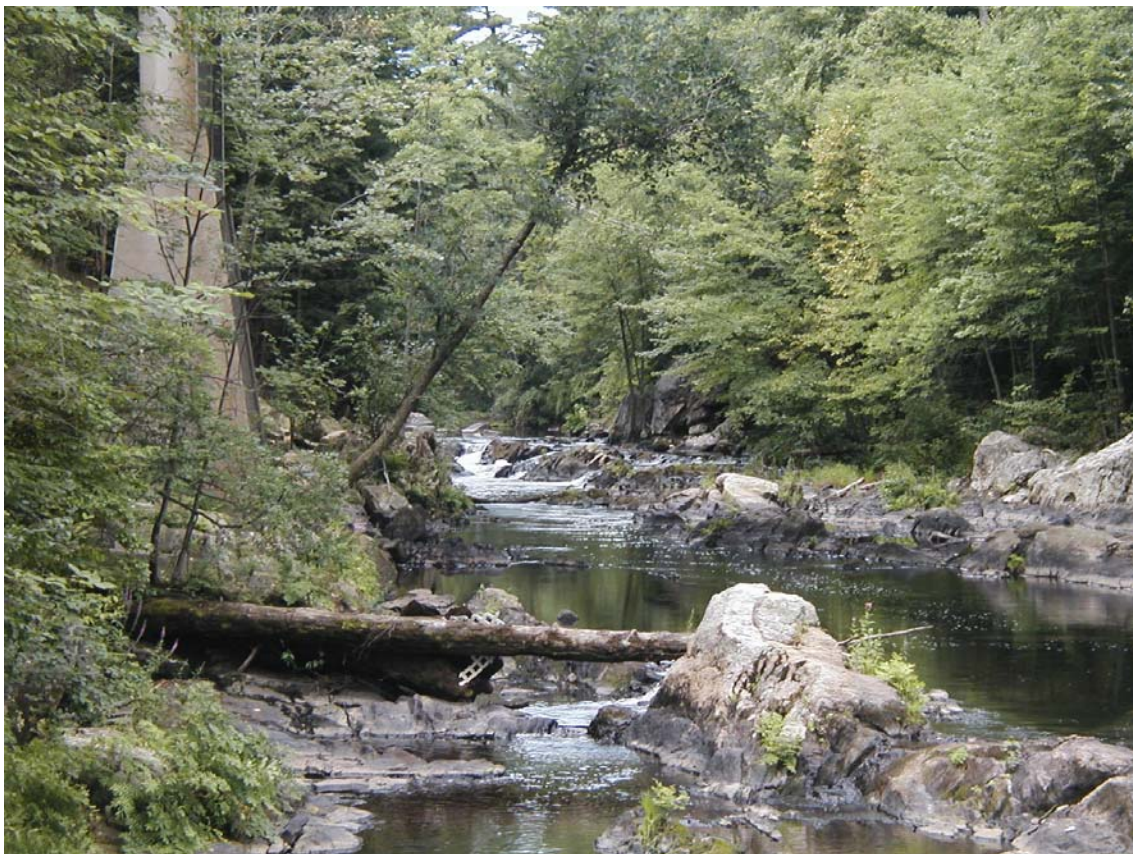
Photo No. 33, Date: 8/6/04, Courtesy Smart Associates

Description: Faster flows are evident at the F.E. Everett bridge crossing.

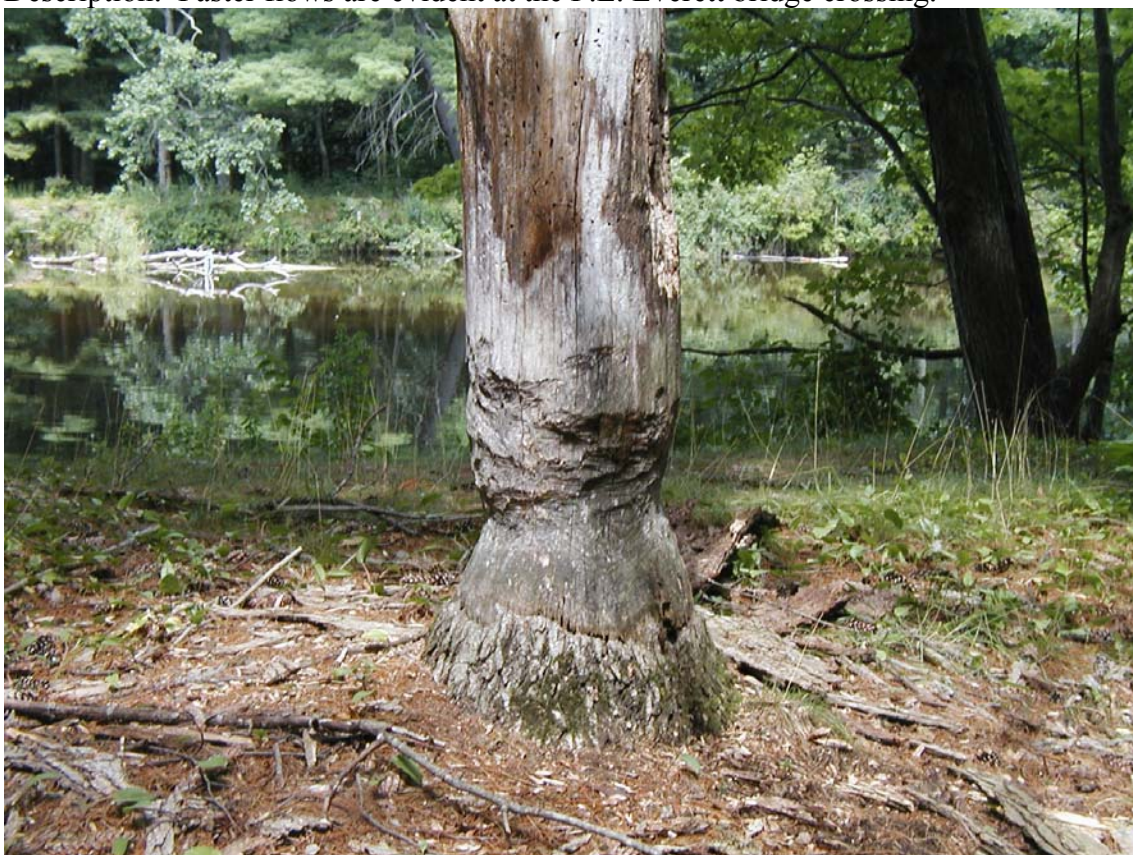
Photo No. 34, Date 8/6/04, Courtesy Smart Associates

Description: Evidence of past beaver activity along the riverbank, upstream of the MVD.

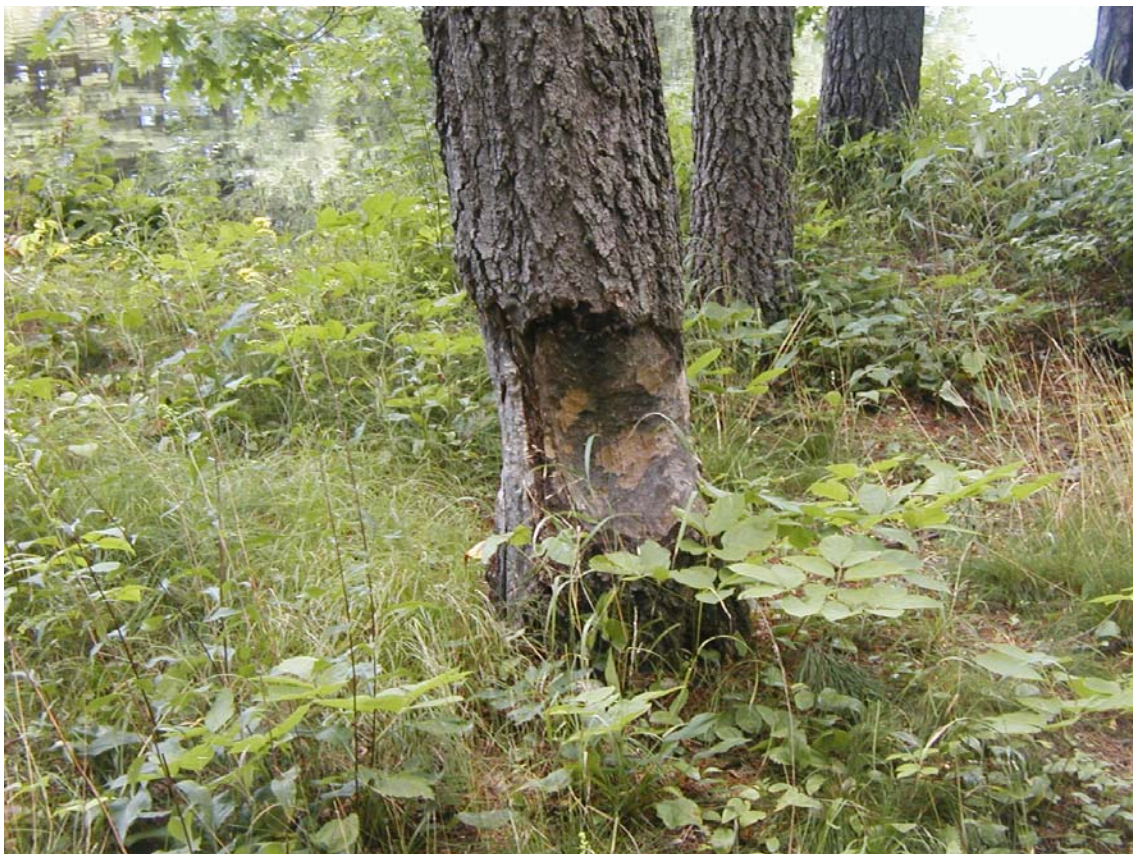
Photo No. 35, Date: 8/6/04, Courtesy Smart Associates
Description: Past beaver activity, upstream of the MVD.

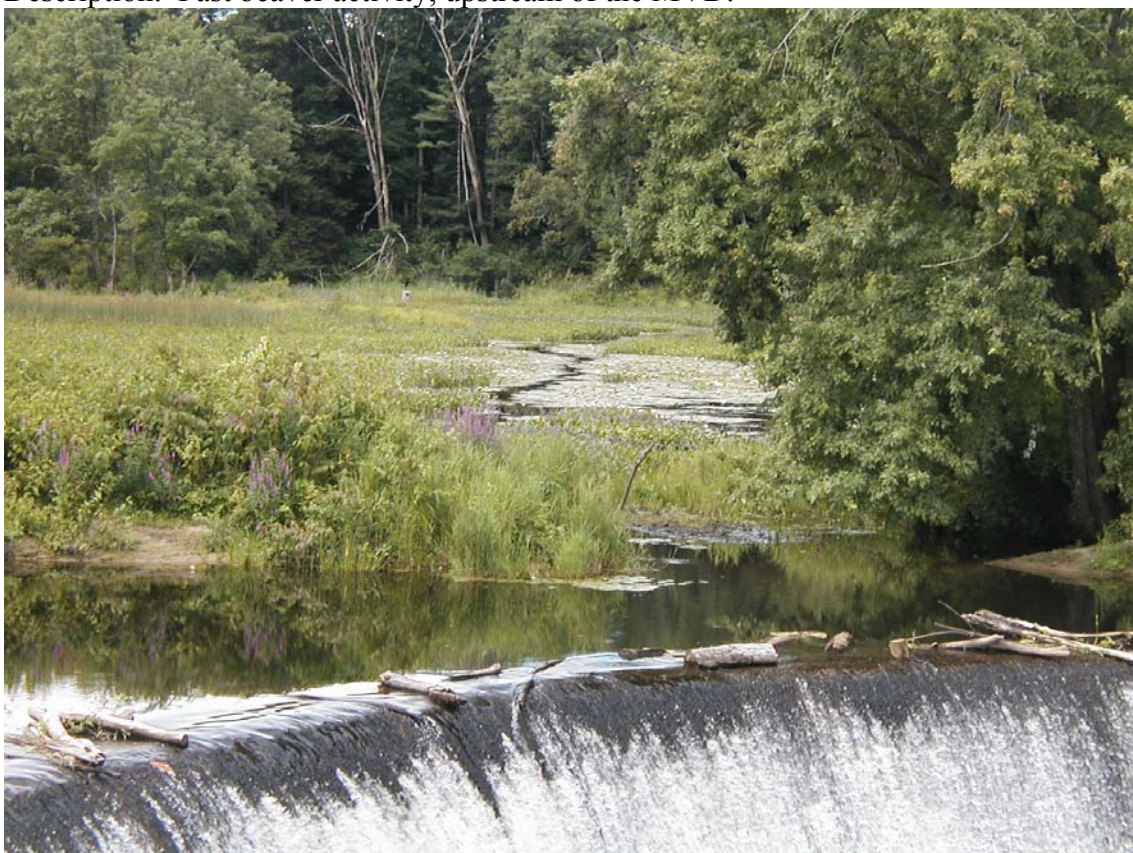
Photo No. 36, Date: 8/6/04, Courtesy Smart Associates
Description: During mid to late summer, the impounded wetland near the Merrimack Fire Station changes.

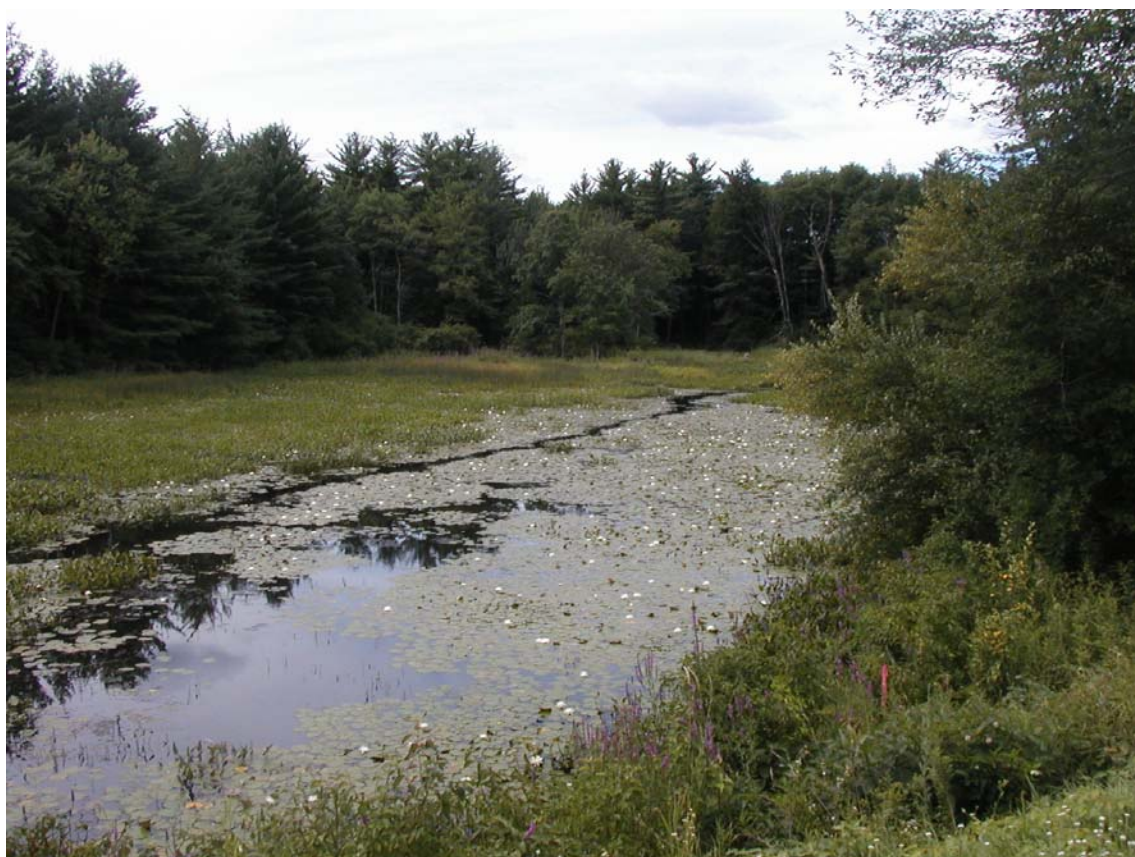
Photo No. 37, Date: 8/6/04, Courtesy Smart Associates

Description: As water levels in the river drop, open water areas in this wetland shrink, and aquatic and emergent vegetation thickens.
